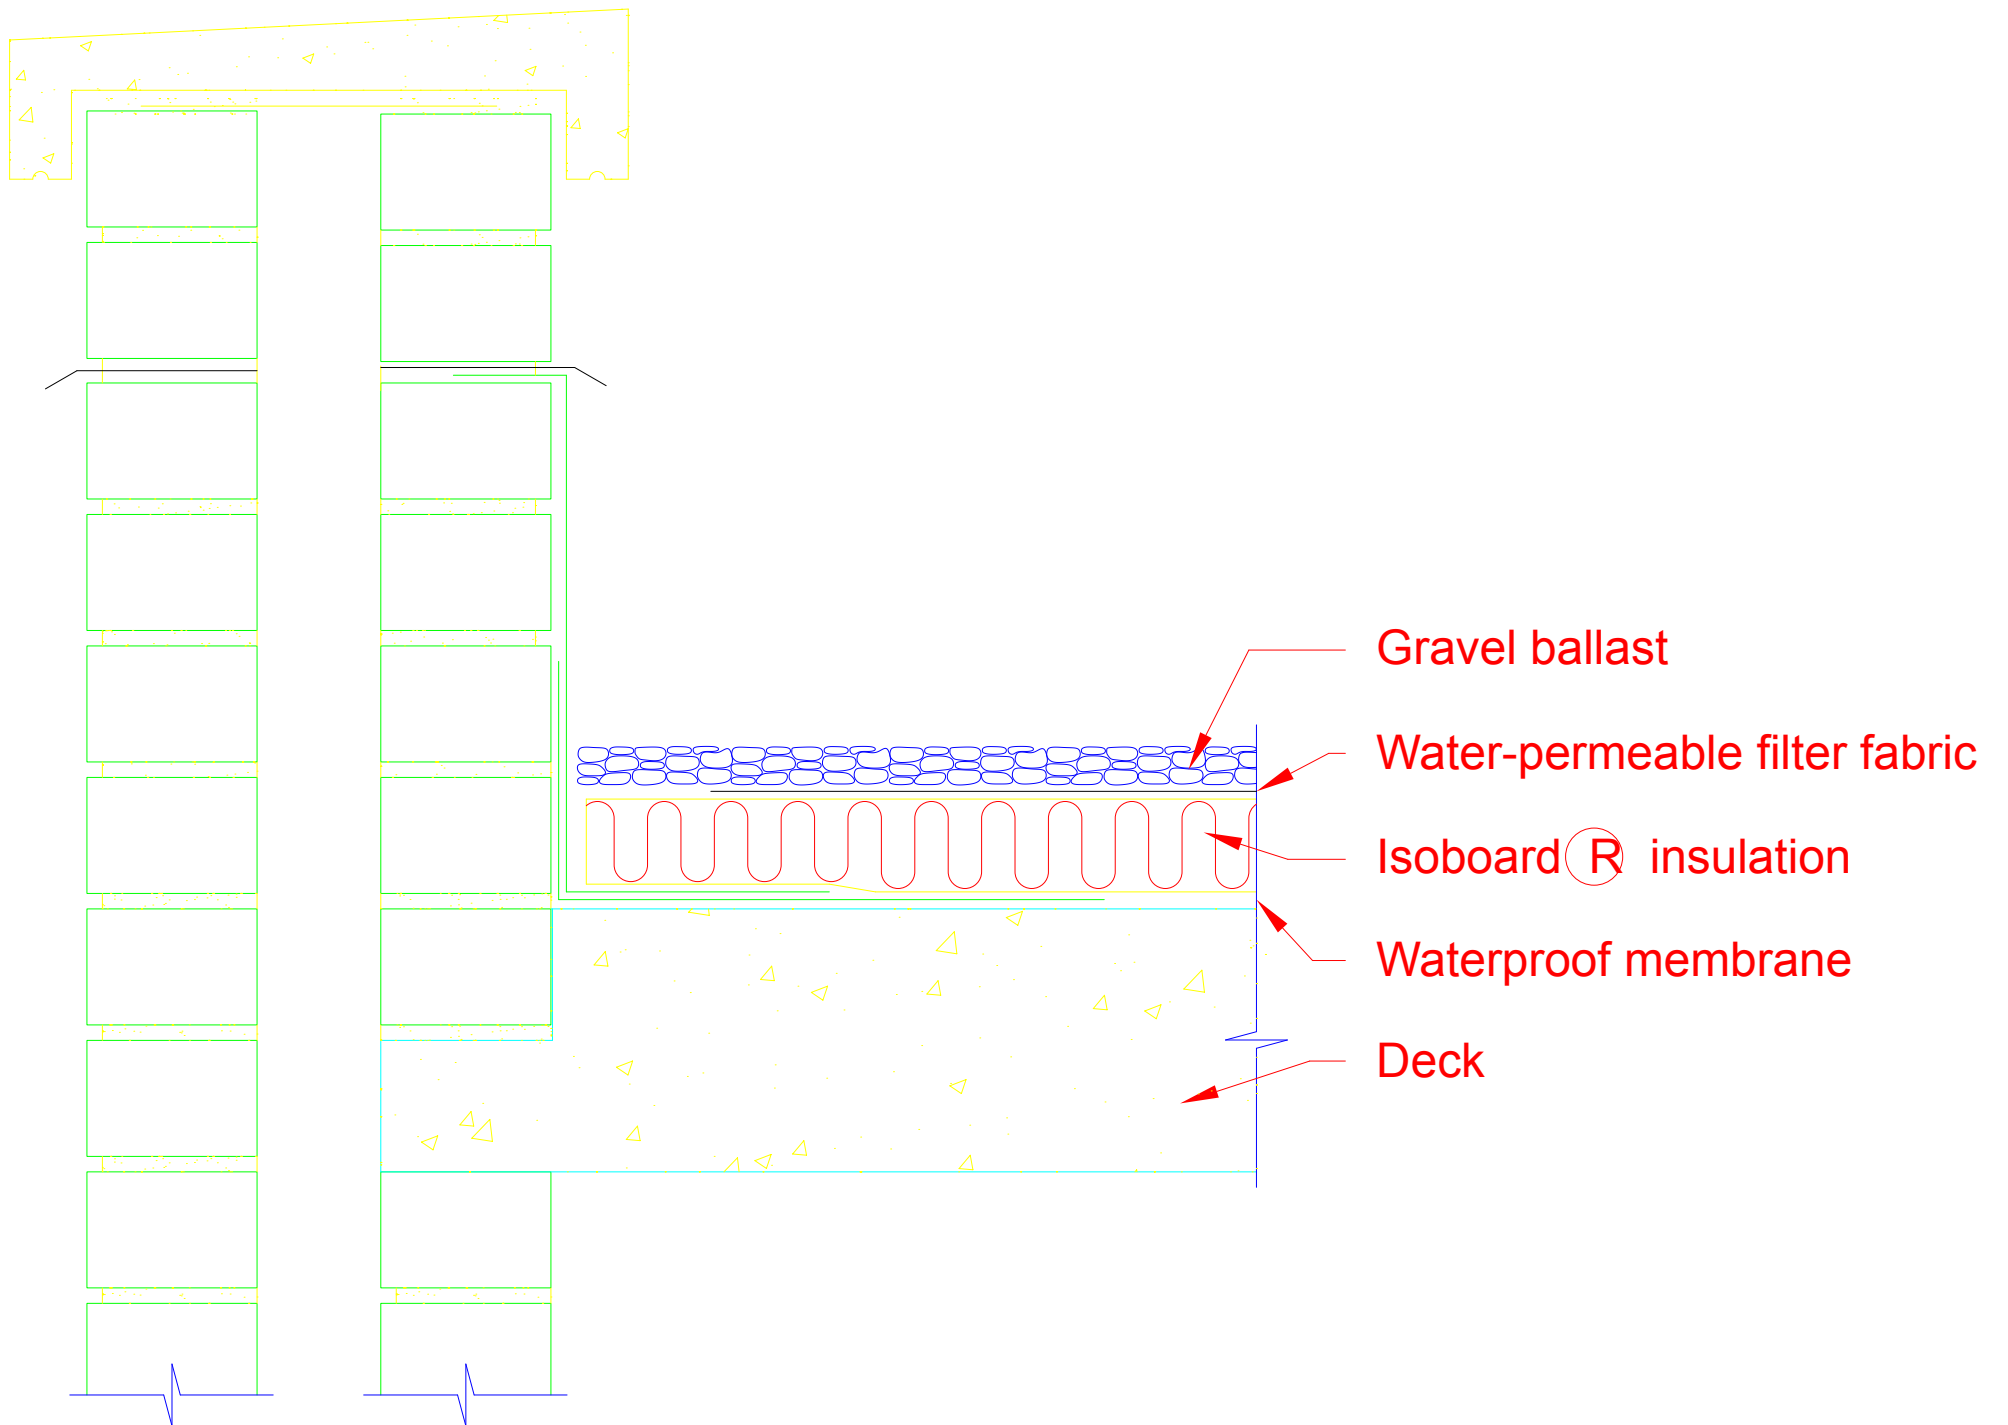
Figure 4

Parapet roof deck detail - tanking specification where falls are not optimum and ponding could occur
